Manhole Inspection Summary

Manhole # S37Y1_027MH

Inspection ☐ Is Incomplete Rating: **3) Fair**

Location Address: **3823 2nd St.**

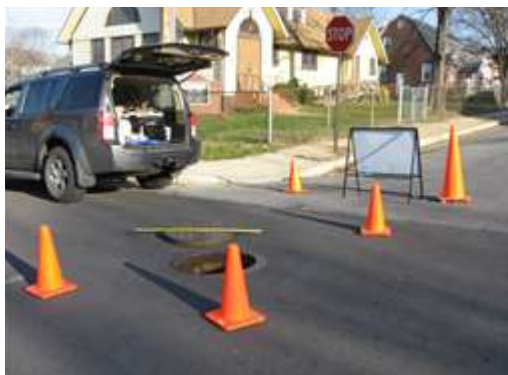
Location View

3800 2nd St

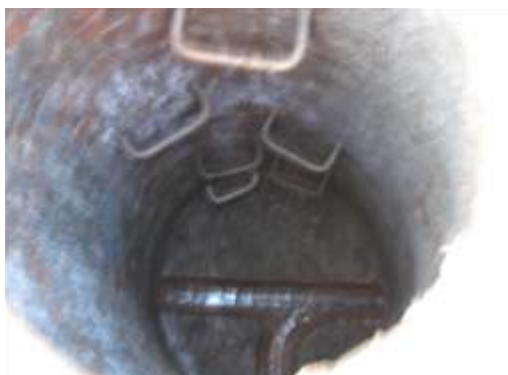
Steps

Count: **6** Missing: **0** ☒ **Corroded**

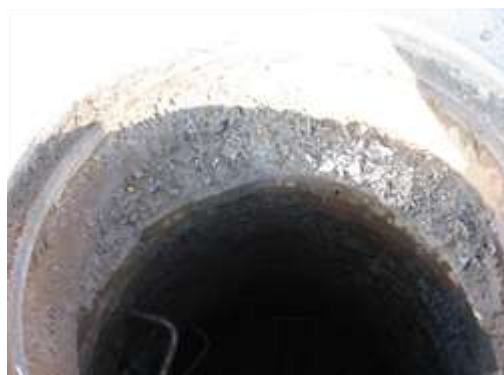
Defect 1

Offset: **3** (in.)

Frame Offset

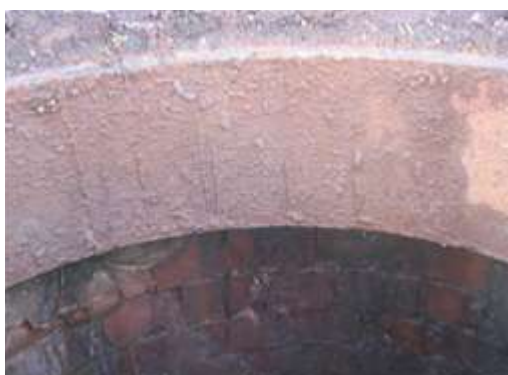
Defect 2

Infiltration: ☐ None ☐ Joint ☐ Cracks ☐ Mortar ☐ Roots ☒ **Wall**

Infiltration

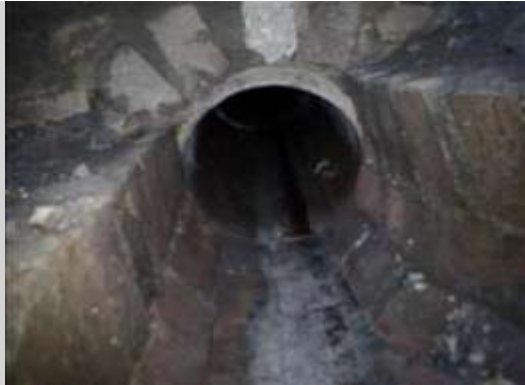
12 O'Clock Outflow

8 in. Circular Gravity Sewer
Pipe Out @ 12 O'Clock

Pipe Height: **9.6** (in.) Rod and Bar (Angled)
Pipe Material: **Clay** ☐ Pipe Lined
Invert Depth: **10.26** (ft.) Flow Characteristics: **Fast**
Deposits: ☒ None ☐ Mud ☐ Sludge ☐ Debris ☐ Grease
Silt Depth: (in.) Deposits Extent:
Infiltration: **None** Pipe Seal Cond: **Sound**

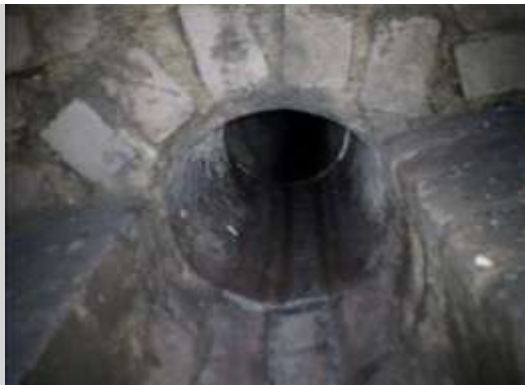
3 O'Clock Inflow

8 in. Circular Gravity Sewer
Pipe In @ 3 O'Clock

Pipe Height: **9.6** (in.) Rod and Bar (Angled)
Pipe Material: **Clay** ☐ Pipe Lined
Invert Depth: **9.76** (ft.) Flow Characteristics: **Fast**
Deposits: ☒ None ☐ Mud ☐ Sludge ☐ Debris ☐ Grease
Silt Depth: (in.) Deposits Extent:
Infiltration: **None** Pipe Seal Cond: **Sound**

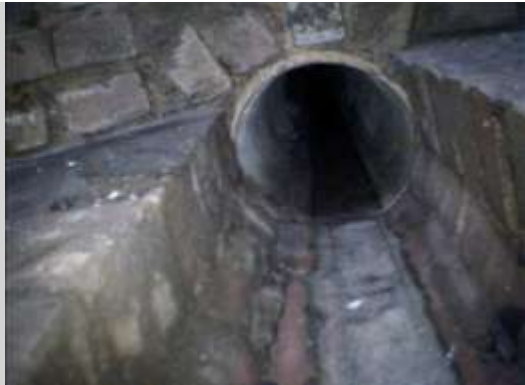
6 O'Clock Inflow

8 in. Circular Gravity Sewer

Pipe In @ 6 O'Clock

Infiltration: **None** Pipe Seal Cond: **Sound**
